AST FAILURE IN STORMS

What are the consequences when above-ground storage tanks (ASTs) are damaged in storms?

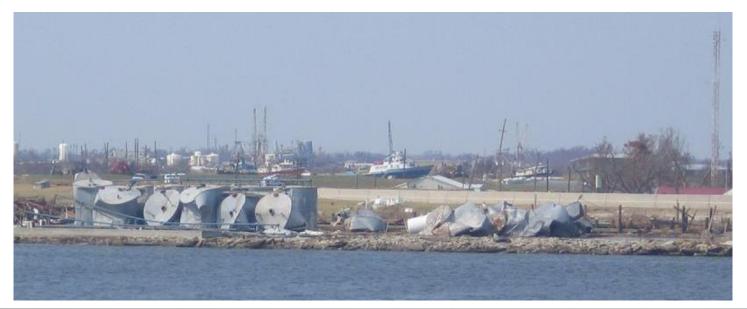
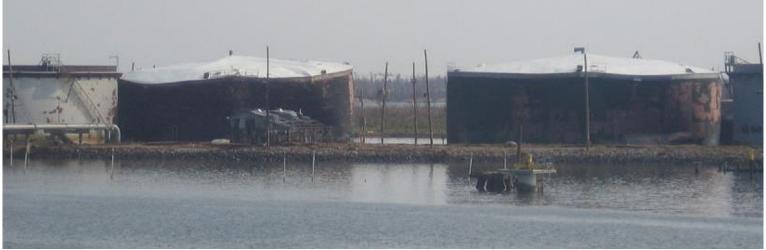
Hurricane Katrina: August 2005, Atlantic Hurricane Rita: Sept 2005, Gulf of Mexico

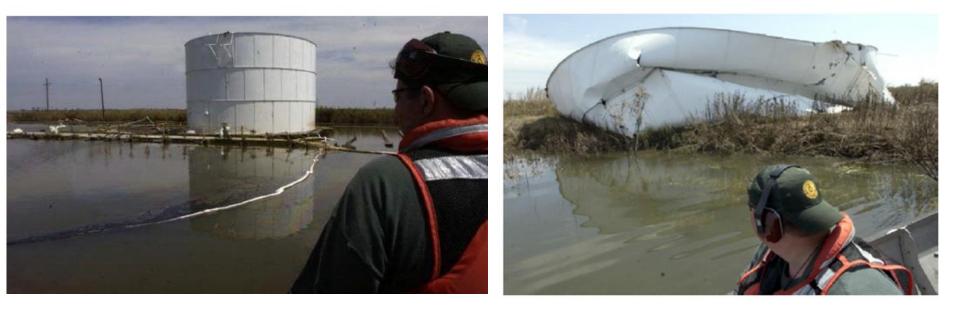
Hurricane Gustav: Aug 2008, Gulf of Mexico Hurricane Ike: Sept 2008, Gulf of Mexico

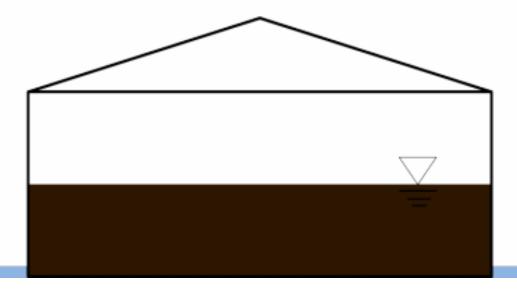
AST DISPLACEMENT

- Flooding causes external water pressure on tank shell
- PLUS: *Debris and wave impact* and external *wind pressure*

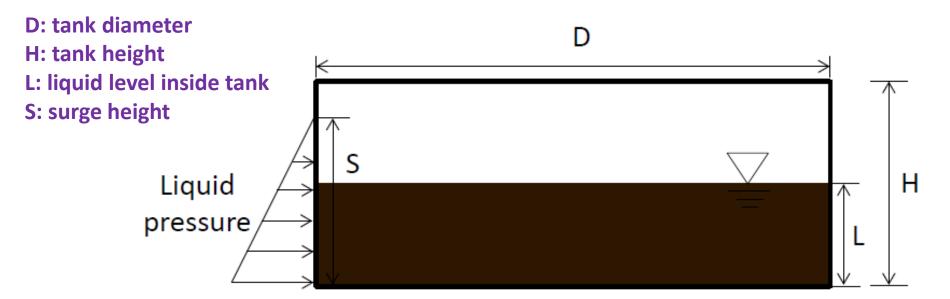
TYPICAL TANK DIMENSIONS

Fixed roof tank (flat roof)

Aspect ratio (H/D): 0.4

Tank diameter: 62 feet

Shell thickness: 0.394 inches

Tank height: 25 feet

Vary S and L
